# Force Sensor Calibration

With use of a Pulse Hammer

# Sensor-Support Calibration

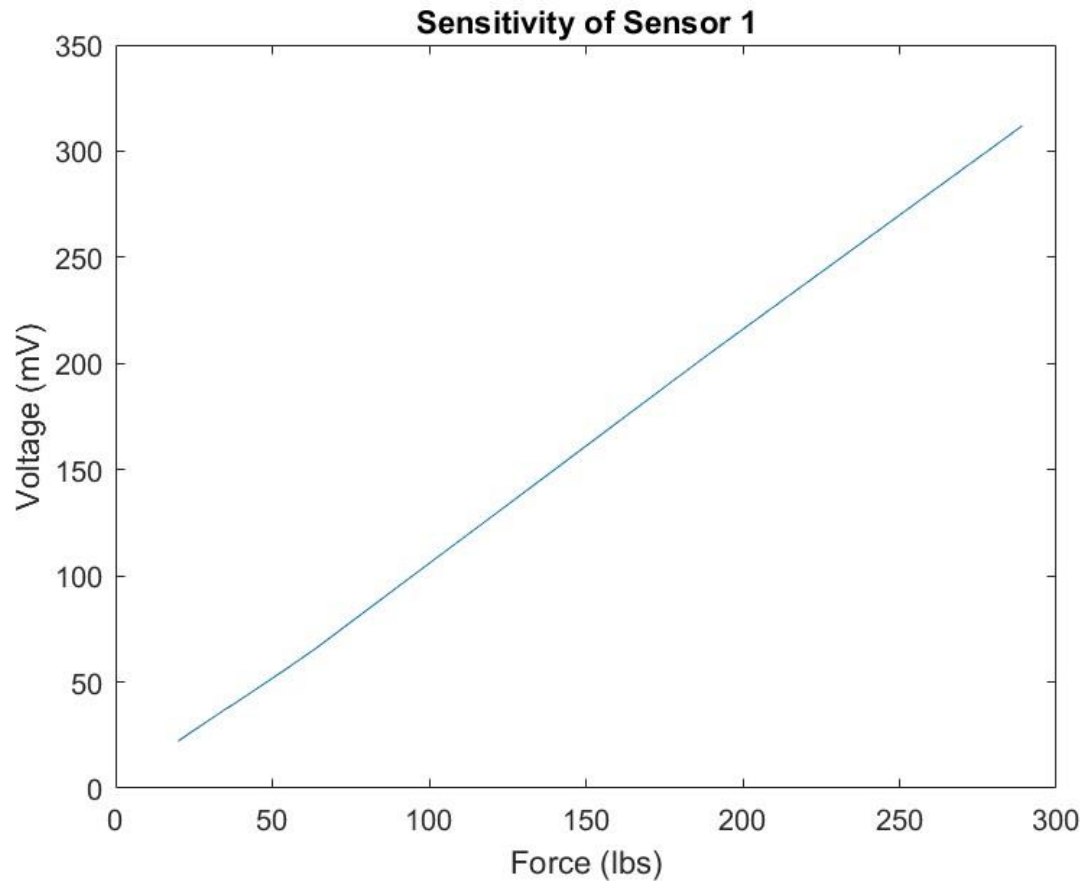
Sensitivity: 1.0838 mV/lb

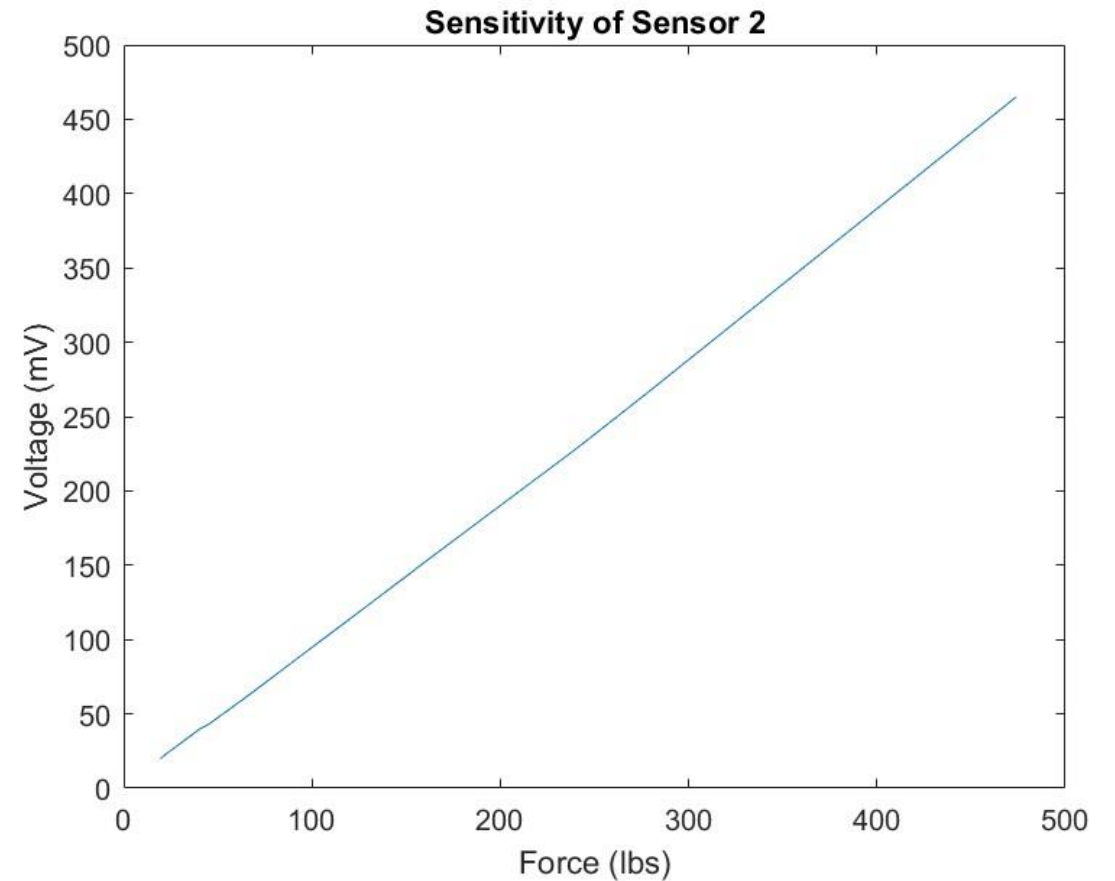
Sensitivity: 0.9735 mV/lb

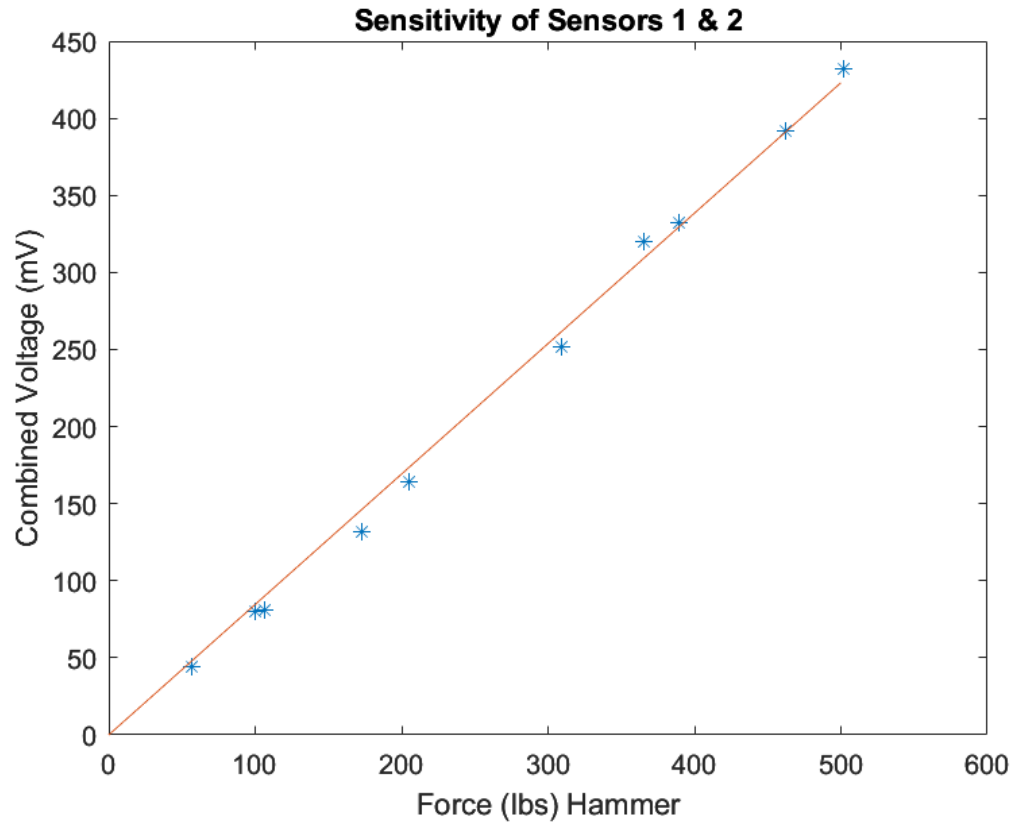
- The Impact Hammer was used in it's full range from 0-500 lbs of force on the flat support.
- Two trials were conducted:
  - 1st: With Sensors 1 & 2
  - 2nd: With Sensors 3 & 4
- A total of 20 data points (10 data points per trial) were collected in the calibration procedure.
- MATLAB analysis
- Excel - Data analysis: Regression (with constant as zero)

Sensitivity: 0.846138 mV/lb
