# 2014 Source Water Assessment

## TRINITY EPISCOPAL CHURCH TRANSIENT NON-COMMUNITY WATER SYSTEM

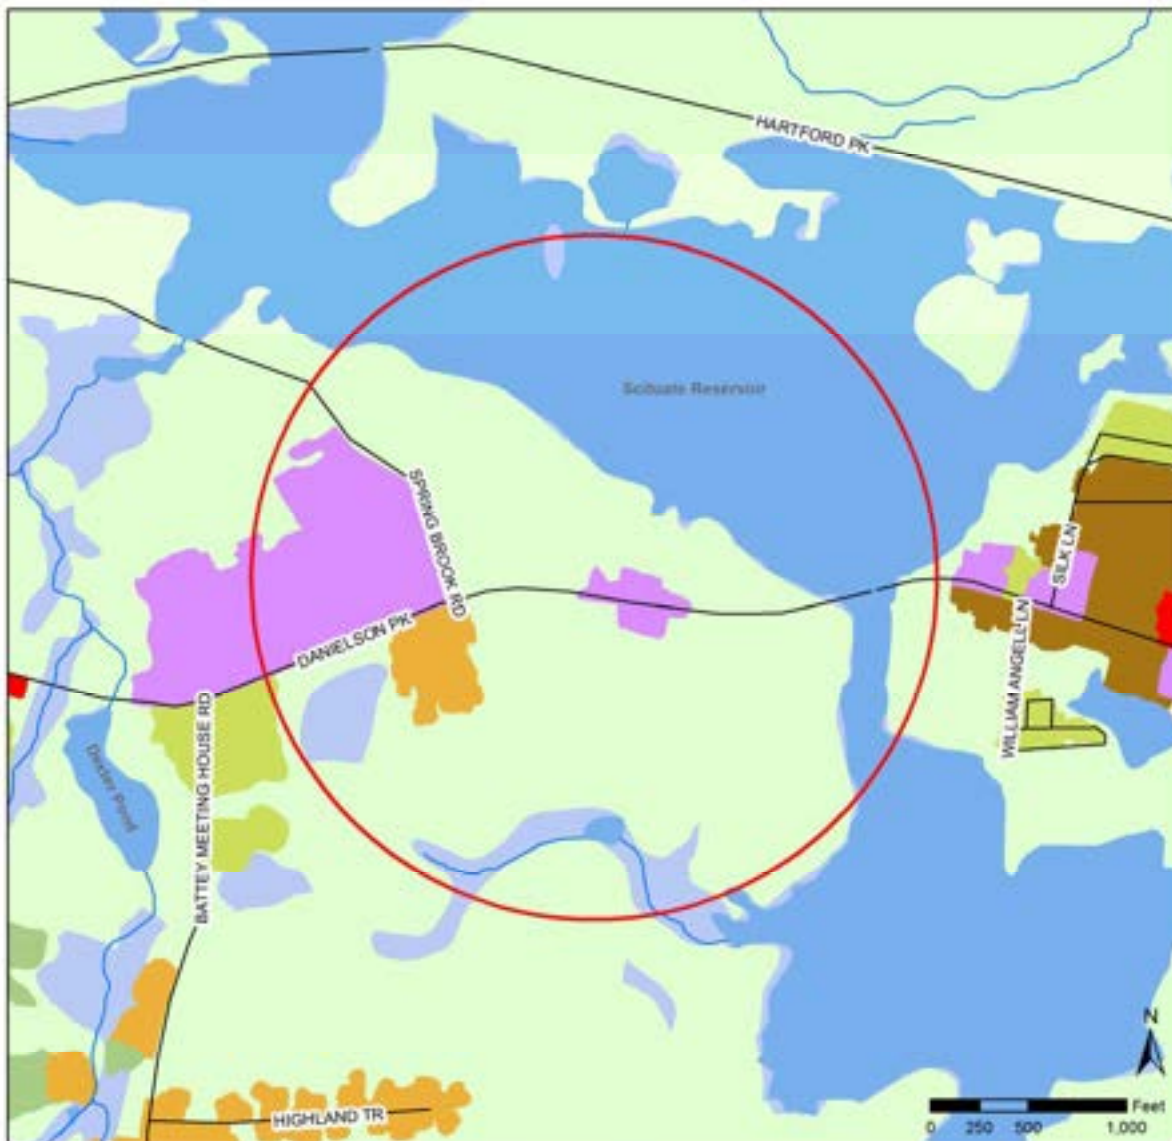
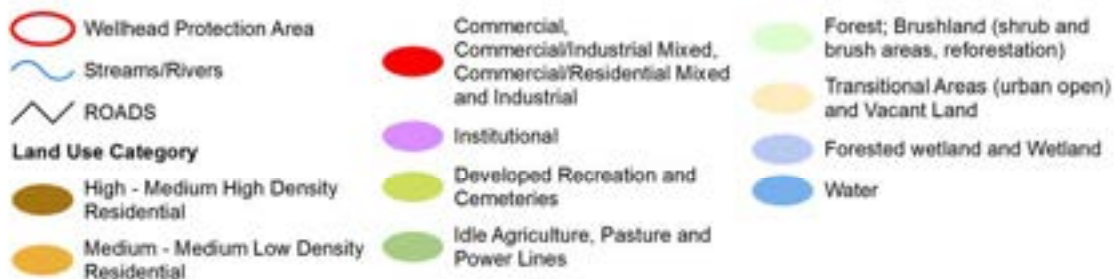
Figure 2 - Land use in the vicinity of the WHPA

A summary of all land uses found within the Trinity Episcopal Church Water System WHPA reveals that 9.5% of the WHPA is considered to be developed as high intensity land use, corresponding with a risk rating of Low (figure 2, table 2). The high intensity land use consists of institutional land uses. The institutional uses include part of the Rhode Island State Police/National Guard/Scituate Maintenance facility and the Trinity Episcopal Church facility.

Data: RIGIS 2011 Land use modified to include forested wetlands, WHPA: RI HEALTH 2014, Stream/Rivers: RIGIS Streams5k
