KINGSTON CAMPUS DRAINAGE MASTER PLAN

University of Rhode Island, Kingston Campus
South Kingstown, Rhode Island

GORDON R. ARCHIBALD, INC.
200 Main Street
Pawtucket, RI 02860

February 2018

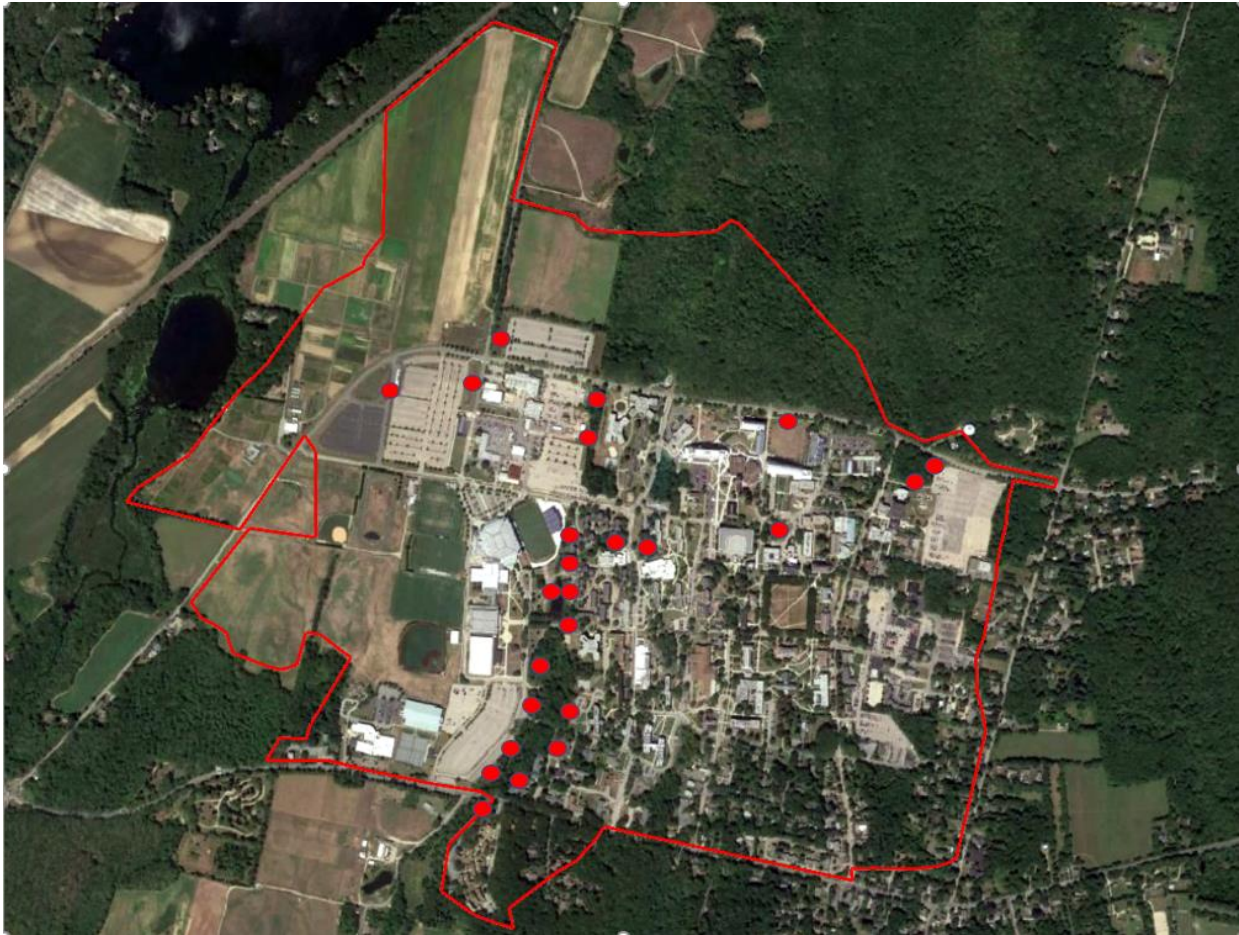
FIGURE 6. POTENTIAL LOCATIONS FOR RAIN GARDENS AND BUFFER / FILTER STRIPS
