RWP BMPs problem areas/before pictures

Sites 3B, 12 and 17_18

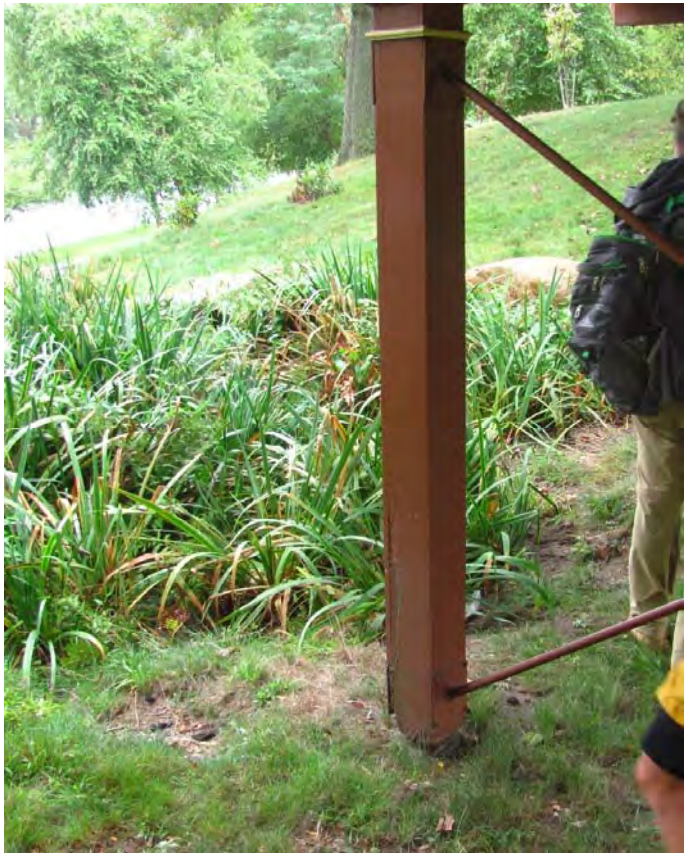
Site 12 cont.

Downslope of bridge. Arrows indicate not-insignificant depression caused by runoff from bridge.
