2014 Source Water Assessment

BEACON FREE WILL BAPTIST CHURCH TRANSIENT NON-COMMUNITY WATER SYSTEM

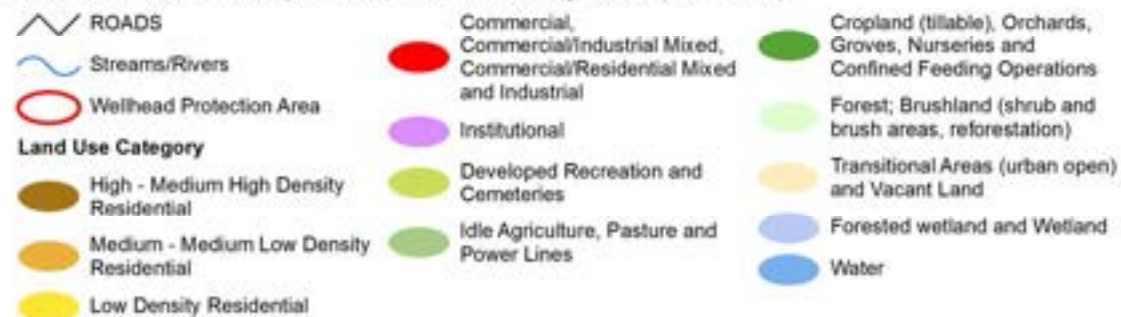
Figure 2 - Land use in the vicinity of the WHPA

A summary of all land uses found within the Beacon Free Will Baptist Church Water System WHPA reveals that 36% of the WHPA is considered to be developed as high intensity land use, corresponding with a risk rating of high (figure 2, table 2). The high intensity land use consists of approximately 33% croplands, 1% commercial and 2% institutional land uses. The commercial and institutional uses include a restaurant, a U.S. Post office, a Catholic Church and part of a department of public works facility for Exeter. This does not include the church facility, as it was most likely constructed after 2011, but it would be classified as institutional, further increasing the percentage of high intensity land use. Prior to construction of the church, the land occupied by the church was considered idle agriculture. It also appears there is some active site work to the south of the church, but it is unclear what is occurring.

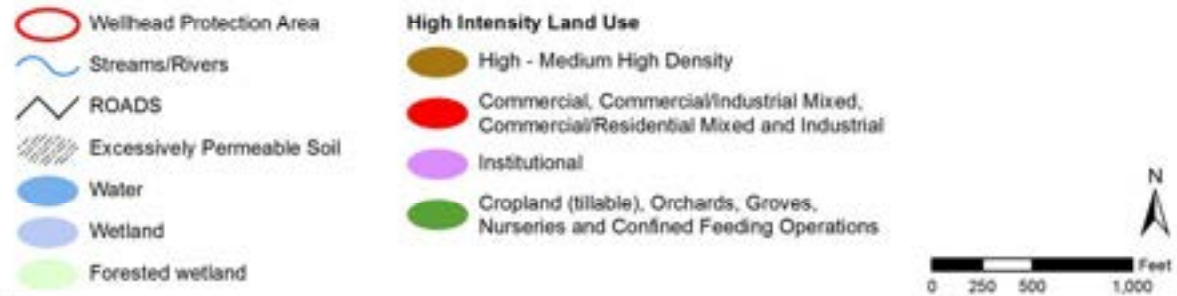
Figure 3 - High intensity land use and excessively permeable soils

The percentage of high intensity land uses on excessively permeable soils in the WHPA is also a risk indicator (figure 3, table 3). Excessively permeable soils (as obtained from the RIGIS 2014 Soils data) allow contaminants and water to rapidly infiltrate into the ground. Excessively permeable soils when located in conjunction with high intensity land uses increase the risk of well contamination. Therefore, when evaluating WHPAs, locating potential pollution sources that lie on excessively permeable soils is an important component of the risk analysis. In the Beacon Free Will Baptist Church Water System WHPA there are 78 acres of high intensity land uses located on excessively permeable soils, which is equivalent to 35% of the total land use, corresponding with a risk rating of extreme. Almost the entire WHPA is located in an area of excessively permeable soil.
