# 2014 Source Water Assessment

## WOONSOCKET CONGREGATION OF JEHOVAH'S WITNESSES TRANSIENT NON-COMMUNITY WATER SYSTEM

**Woonsocket Congregation of Jehovah's Witnesses (TNC) (2980440)**

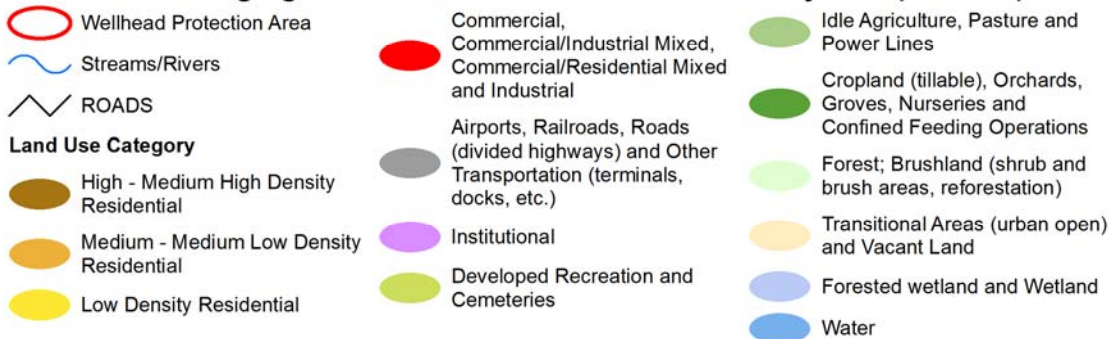
Figure 2 - Land use in the vicinity of the WHPA

A summary of all land uses found within the Woonsocket Congregation of Jehovah’s Witnesses Water System WHPA reveals that 11.7% of the WHPA is considered to be developed as high intensity land use, corresponding with a risk rating of Medium (figure 2, table 2). The high intensity land use consists of high density residential (3.8%), medium-high density residential (1.4%), commercial (3.8%), institution (1.0%) and orchards (1.7%) land uses. The institutional use is the Jehovah’s Witness facility. The commercial uses are mainly retail and restaurants. The small area of commercial use near the Jehovah’s Witness facility appears to be a large garage associated with a home, there are multiple trucks in the driveway, but the location is not identified as a business based on internet searches of the address.

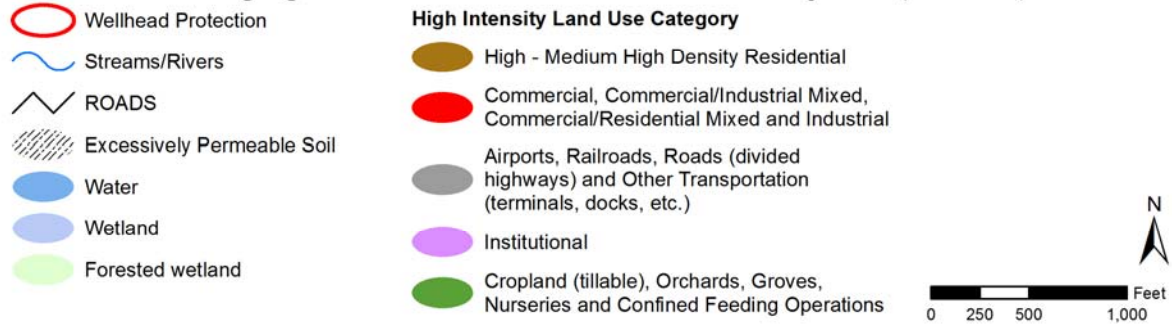
Figure 3 - High intensity land use and excessively permeable soils

The percentage of high intensity land uses on excessively permeable soils in the WHPA is also a risk indicator (figure 3, table 3). Excessively permeable soils (as obtained from the RIGIS 2014 Soils data) allow contaminants and water to rapidly infiltrate into the ground. Excessively permeable soils when located in conjunction with high intensity land uses increase the risk of well contamination. Therefore, when evaluating WHPAs, locating potential pollution sources that lie on excessively permeable soils is an important component of the risk analysis. In the Woonsocket Congregation of Jehovah’s Witnesses Water System WHPA 5.8 acres of high intensity land uses are located on excessively permeable soils, which is equivalent to 2.6% of the total land use, corresponding with a risk rating of low.
